Docket No. 217 – Development and Management Plan Inspection

Northeast Utilities Service Company Certificate of Environmental Compatibility and Public Need for the construction of a 345-kV electric transmission line and reconstruction of an existing 115-kV electric transmission line between Connecticut Light and Power Company's Plumtree Substation in Bethel, through the towns of Redding, Weston, and Wilton, and to the Norwalk Substation in Norwalk, Connecticut.

Date: July 19, 2006

Location: Transition Stations: Hoyts Hill, Archers Lane, Norwalk Junction

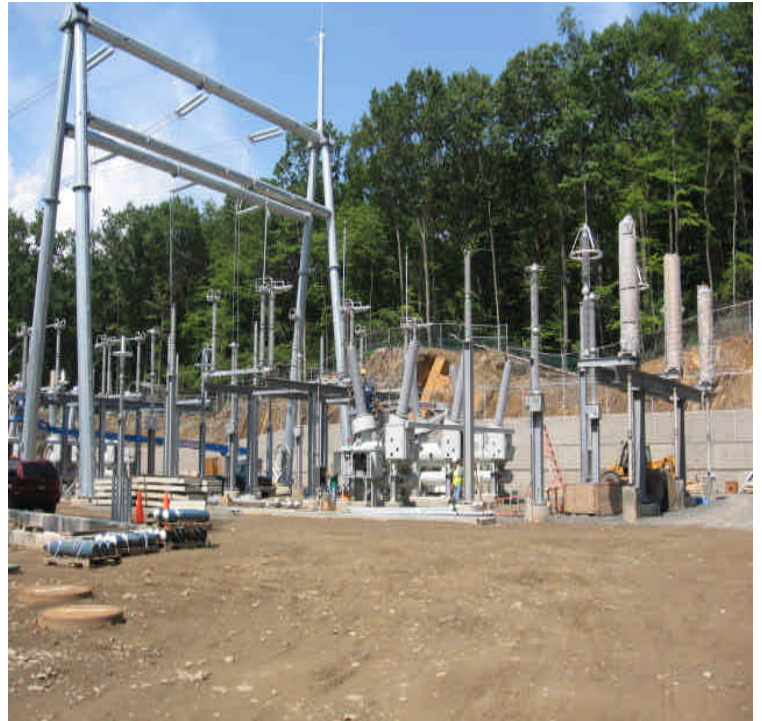
Archers Lane: Photo on the left shows turbid run-off ponding at the access drive. Continue to maintain controls so this water is filtered before entering the wetland. If this ponding is an issue consider haybales or small stone berms in place of silt fence Photo on the right shows an overview of the work and structures in the station yard. 7/19/06.
